Old Photographs as a Source of Archaeological Information in the Study of Jerusalem The Case of Birkat Sit Maryam

David Gurevich

Department of Archaeology, University of Haifa

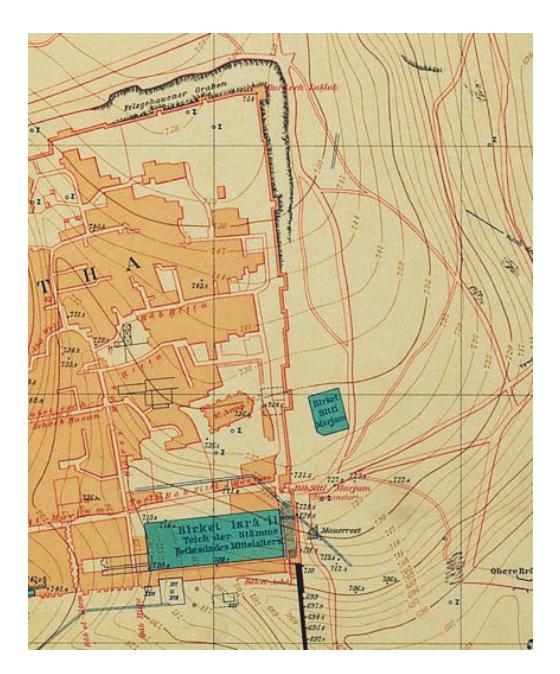
Fig. 1: Birkat Sit Maryam and its surroundings in the Kuemmel map, 1904.

Birkat Sit Maryam is a small pool, located about 50 m from Lions' Gate in the area of the present-day al-Yusifiyeh Muslim cemetery (Fig. 1). The pool, in which scholars showed no interest in the past, has never been excavated; consequently, information about it is meager; the installation is currently covered with earth and scholars do not know what it looks like.

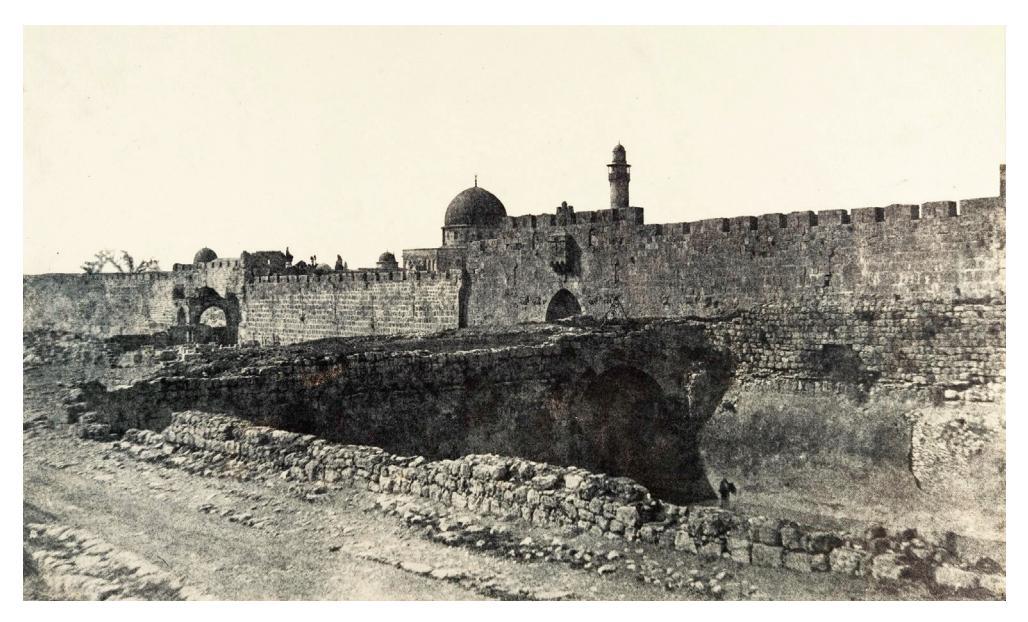
Fig. 2: Birkat Sit Maryam, in Auguste Saltzmann's 1854 photograph, looking southwest.

Saltzmann took the photograph of Birkat Sit Maryam from the southeast. It shows the upper part of the pool's walls in a very poor state of preservation. Plaster can also be seen on the walls, covering their lower parts more or less to the level of the surface outside the pool. Above the plastered portion, roughly dressed stones can be seen. The upper part of the pool may have been built as an addition to the walls to raise the pool slightly above ground level. A vault appears at the southwestern corner of the pool. An installation of unclear purpose is situated on the vault.

The earliest photograph of Birkat Sit Maryam was apparently taken by the French photographer Auguste Saltzmann, who visited Jerusalem in 1854 (Fig. 2). Significantly, photographic technology had only been invented a few years before his visit, in 1839. Saltzmann took the photographs to illustrate the studies of the French scholar Louis Félicien de Saulcy, which had been published a few years before and had been dubiously greeted by European scholars. Saltzmann believed that these scholars doubted de Saulcy's conclusions because they had not seen the sites for themselves, an obstacle he sought to overcome through his photographs (Donadio 2008: 143-145). This fact makes Saltzmann's work important to archaeological research today, because many of

A comparison of the photographs from the nineteenth century (Figs. 2, 3) to those from the early twentieth century (Figs. 5, 6) allows us to distinguish changes to the pool and apparent extensive renovation of its walls. This renovation should be dated to the period between the Zangaki brothers' photo (1890) and the Halladjian photo (between 1904 and 1907). Apparently during the renovation a new installation was built at the southwestern corner of the pool to convey water to the bathhouse.

However, it is unlikely that when the pool was built, its only source of water was rainfall directly into it. Saltzmann's and the Zangaki brothers' photos show plaster coating the sides of the pool almost to its bottom (Figs. 2, 3). Jerusalem's annual average rainfall is *ca* 500 mm (Benami Amiel *et al.* 2010: 1467). If the pool was intended to collect only rainwater, there would have been no need to plaster it all the way to the bottom (approximately 4 m); a plaster coating about 0.6 m above the bottom would have sufficed. Thus, we may conclude that when the pool was built, it was to have served as a reservoir for water reaching it from an outside source.

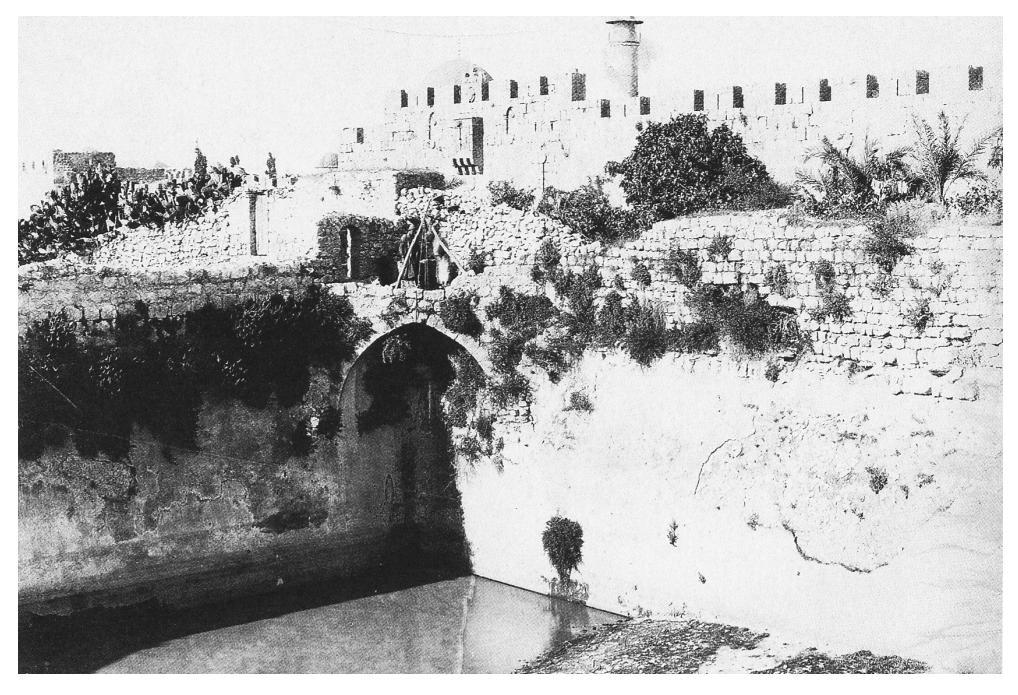
This photograph also shows the southwestern corner of the pool. It resolves the question of the purpose of the vault and the installation constructed above it – two men are seen drawing water from the pool while standing on the vault and the installation held a rope attached to a vessel that was lowered into the pool to draw water. There was apparently an opening in the floor of the vault through which the vessel was lowered. The walls of the pool are still in very poor condition in this photograph, which also reveals that the floor of the pool was uneven. The northern part of the pool may have been full of garbage and consequently water collected only in the southern part. ⁷ Remnants of plaster can also be seen on the walls of the pool in this photograph. It also shows that a gated fence, which can be seen behind the vault, had been constructed around the pool.

Fig. 3: Birkat Sit Maryam, photograph by the Zangaki brothers, 1890, with caption: "Men getting water from the pool outside the wall."

Saltzmann's photograph of Birkat Sit Maryam allows the pool to be identified in another photograph (Fig. 3), taken in 1890 by the Zangaki brothers. The caption does not mention the place where the picture was taken; rather, it merely reads: "Men getting water from the pool outside the wall." However a close comparison of the details of this photograph with that of Saltzmann's leaves no room for doubt – it is Birkat Sit Maryam.

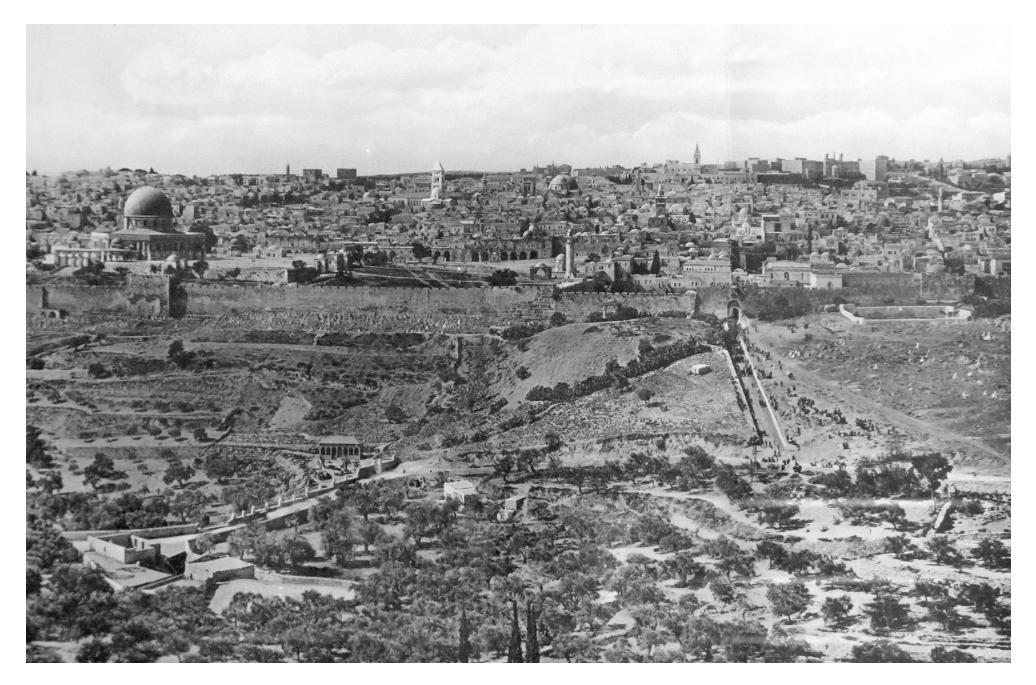
Another significant photograph for our subject was found at the Talitha Kumi School in Beit Jala (Fig. 4). Undated and previously unknown, it shows the area around Lions' Gate from the direction of the Mount of Olives. The photographer's name, J.H. Halladjian, appears in the lower left-hand corner of the image. An enlargement of Birkat Sit Maryam in the photograph allows us to perceive a number of additional characteristics about the pool. It shows the pool raised above ground level (Fig. 5) and that its walls had clearly been renovated compared to the two previous photos. The renovations might still have been underway when the photo was taken, because there is a gap in the construction on the northern wall. In the southeastern corner the entranceway to the pool enclosure can be seen. Behind that entranceway was probably a staircase that led to the bottom of the pool, described by Barclay; however due to the angle of the photograph, it cannot be seen.

Fig. 4: Birkat Sit Maryam and the eastern wall of the old City. Photograph: J.H. Halladjian, no date.

How can the date of the photo be determined? A photographer by the name of J.H. Halladjian was active in Jerusalem and Haifa at the end of the nineteenth century (Onne 1980: 90; Ankori 2006: 36) and until the early twentieth century (Nir 1985: 125, 276, n. 23). To arrive at a more precise date, we will use a number of structures that appear in the photo as chronological anchors.

The date of the photograph may be determined by cross-referencing all the data. Firstly, it could not have been taken before the statue of Mary was installed on the roof of Notre Dame (1904). Thus, that statue is the *terminus post quem* ("limit after which") for the Halladjian photo. ⁸ The story added to the San Salvador tower in 1932 is the *terminus ante quem* ("limit before which") for the photo. The photo was taken some time in period between 1904 and 1932, when the clock tower was not on top of Jaffa Gate. This was theoretically possible in two time periods:

- A. Between 1904 and 1907, before the Jaffa Gate clock tower was built.
- B. Between 1922 and 1932, after the Jaffa Gate clock tower was dismantled by the British authorities.

Considering the period Halladjian was active, the early twentieth century is the most reasonable choice, and therefore it may be assumed that the photo was taken between 1904 and 1907.

taken, the northern wall of the pool had already been completed, unlike its appearance in the Halladjian photograph (Fig. 4); that is, the renovations were finished. In the southwestern corner of the pool a new installation can be seen that is higher than the pool's walls. This was probably an installation used to draw water from the pool and direct it toward the bathhouse, as the Baedeker guide noted in 1912 (1912:74). This installation probably replaced the improvised apparatus seen in this corner on Zangaki photograph (Fig. 3) In this photo the al-Yusufiya Muslim cemetery is still small and most of it is east of the pool and of the pedestrian path.

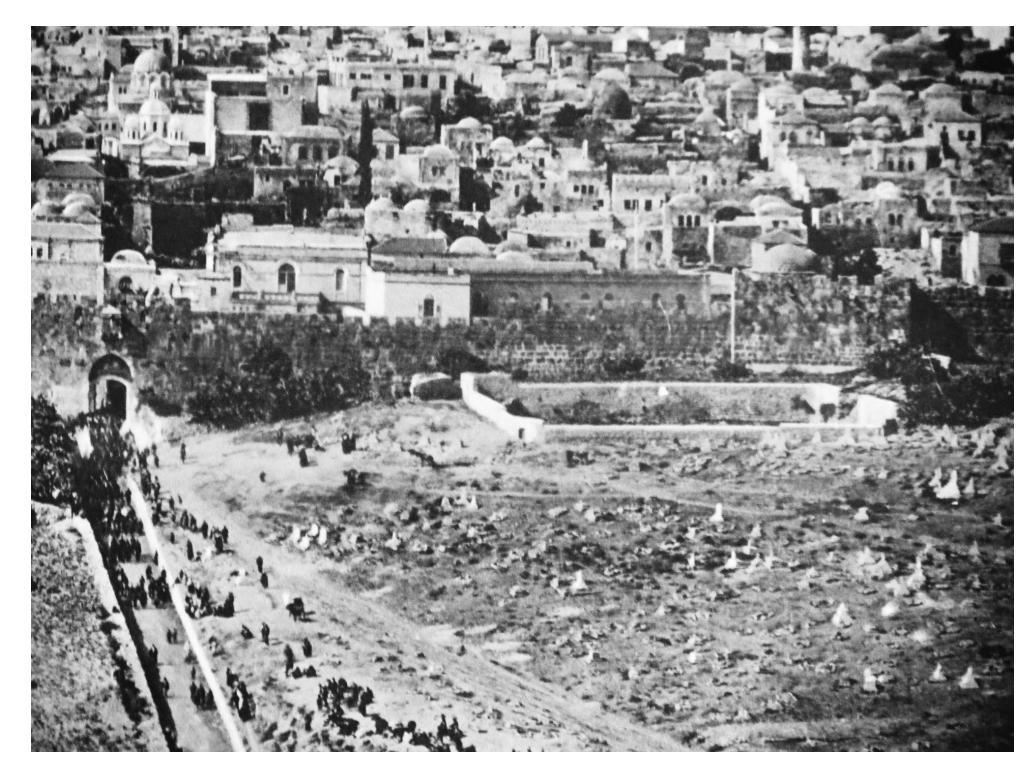
Fig. 5: Birkat Sit Maryam, enlargement from Fig. 4.

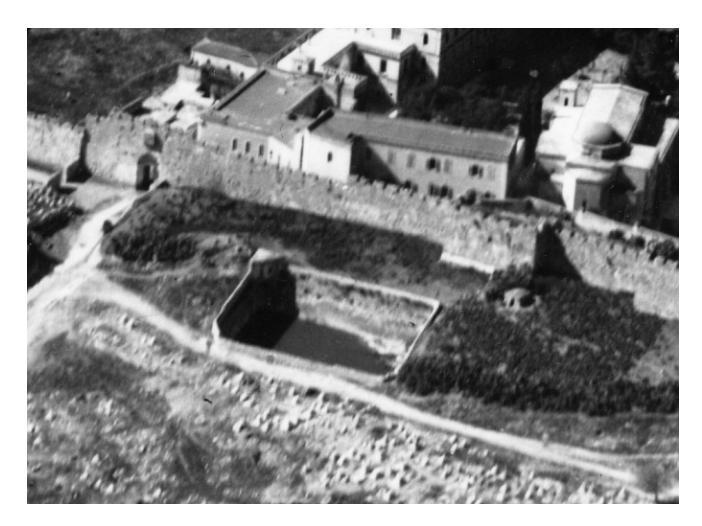
Fig. 6: Birkat Sit Maryam, from an aerial photograph of Jerusalem by the German Air Force in World War.

The photograph (Fig. 6) reveals that during this time the pool's plan was rectangular and its corners were slightly rounded. When the photograph was

The pool is also seen in aerial photographs of Jerusalem taken by the German Air Force in World War I (Fig. 6, for example) ⁹. Most of the original photographs are held in the Bavarian War Archive in Germany (Bayerisches Kriegsarchiv, see: Gavish 1978: 134-143). The photographs, which were taken for military purposes, document extensive areas of Jerusalem from above. Because most aerial photos are taken at very high resolution, they constitute a valuable source of information and in many cases a unique one, about archaeological sites that were subsequently covered up or destroyed in the twentieth century. Because these photos cover such large areas, we can distinguish specific sites in them that did not attract the attention of ordinary photographers. Moreover, the advantage of aerial

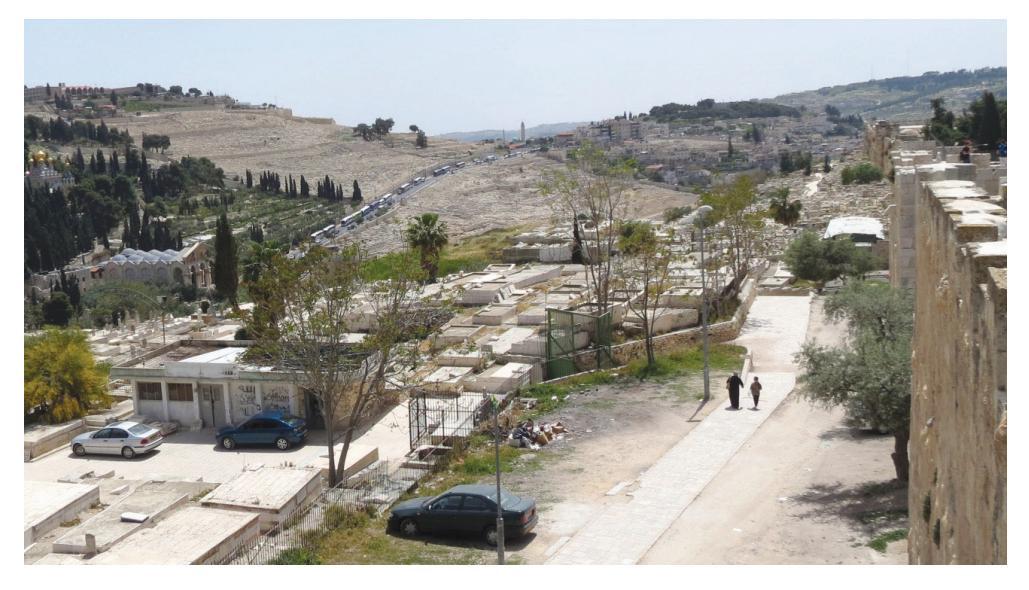
Fig. 7: View of the site of the Birkat Sit Maryam's location in the al-Yusufiya Cemetery. Photograph from the Old City Walls, April 2014.

Today the al-Yusufiya Cemetery almost completely covers the hill northeast of Lions Gate (Fig. 7). It was apparently only in the 1990s, with the expansion of the cemetery, that the pool was blocked.¹⁰
